KODACHROME SLIDES \* REGION 5

Furnished by Harold J. Swan, Head, Regional Current Information Section

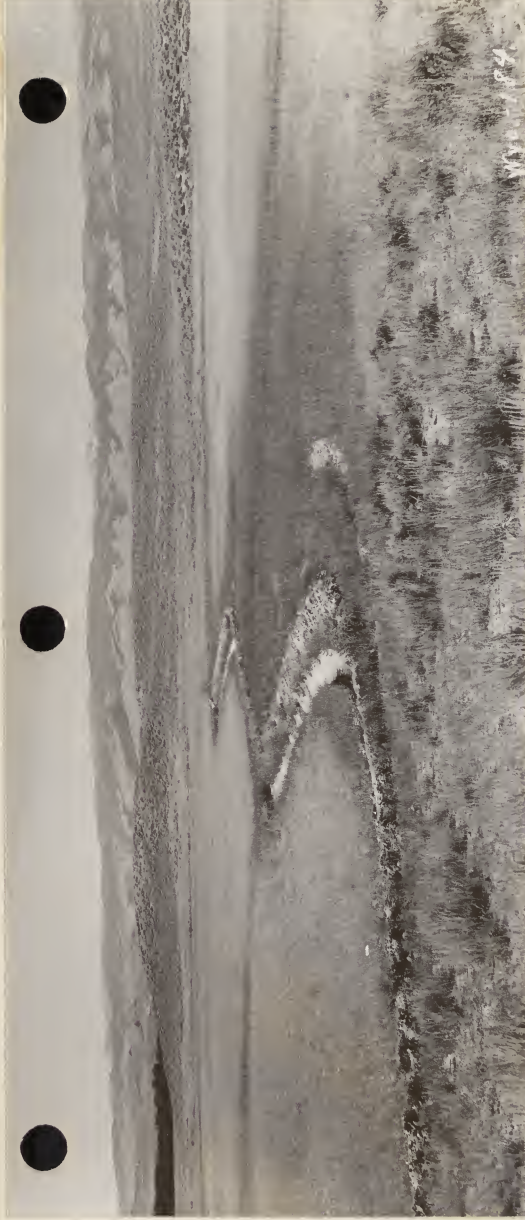
Wyo-184

The effect of water spreading in increasing grass growth in the Big Horn draw of the Lander SCS area near Riverton, Wyoming, is shown in this picture taken 2 miles north and west of Ethete, where the drainage empties into the Little Wind River. The more luxuriant, greener grass, chiefly western wheatgrass and grama, out from the spreader ditches where the water extended, is plainly noticeable in the photograph, after summer rains.

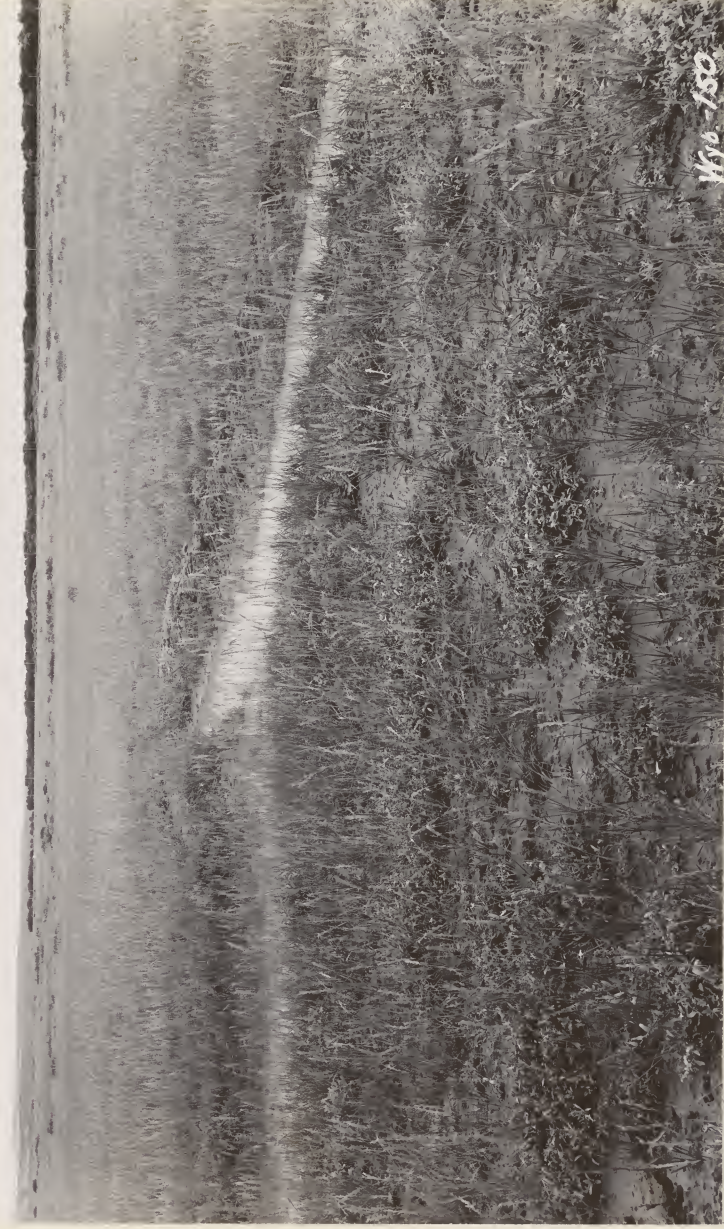
Wyo-150

This picture shows both the manner in which water is spread on the range land of the Big Horn drainage in the Lander SCS proj. area thru a system of combination stock water and water spreading dams & the direct results thereof. Here the water has backed up from the small spreader dike, covering the entire area behind the dike, itself one of a network of spreader structures to distribute overflow water from the spillway of approx. 50 dams. Note the good growth of grass displacing sage, chiefly western wheatgrass & blue gramma, as far as the water spreading line reaches. This & even a better growth was typical over hundreds of acres in the Big Horn area when this picture was taken, despite the fact that less than a year earlier sage and sparse, dry vegetation predominated over most of the drainage. Division of the range into summer, spring and fall and winter grazing areas gave the grass full opportunity to reseed and not be overgrazed.

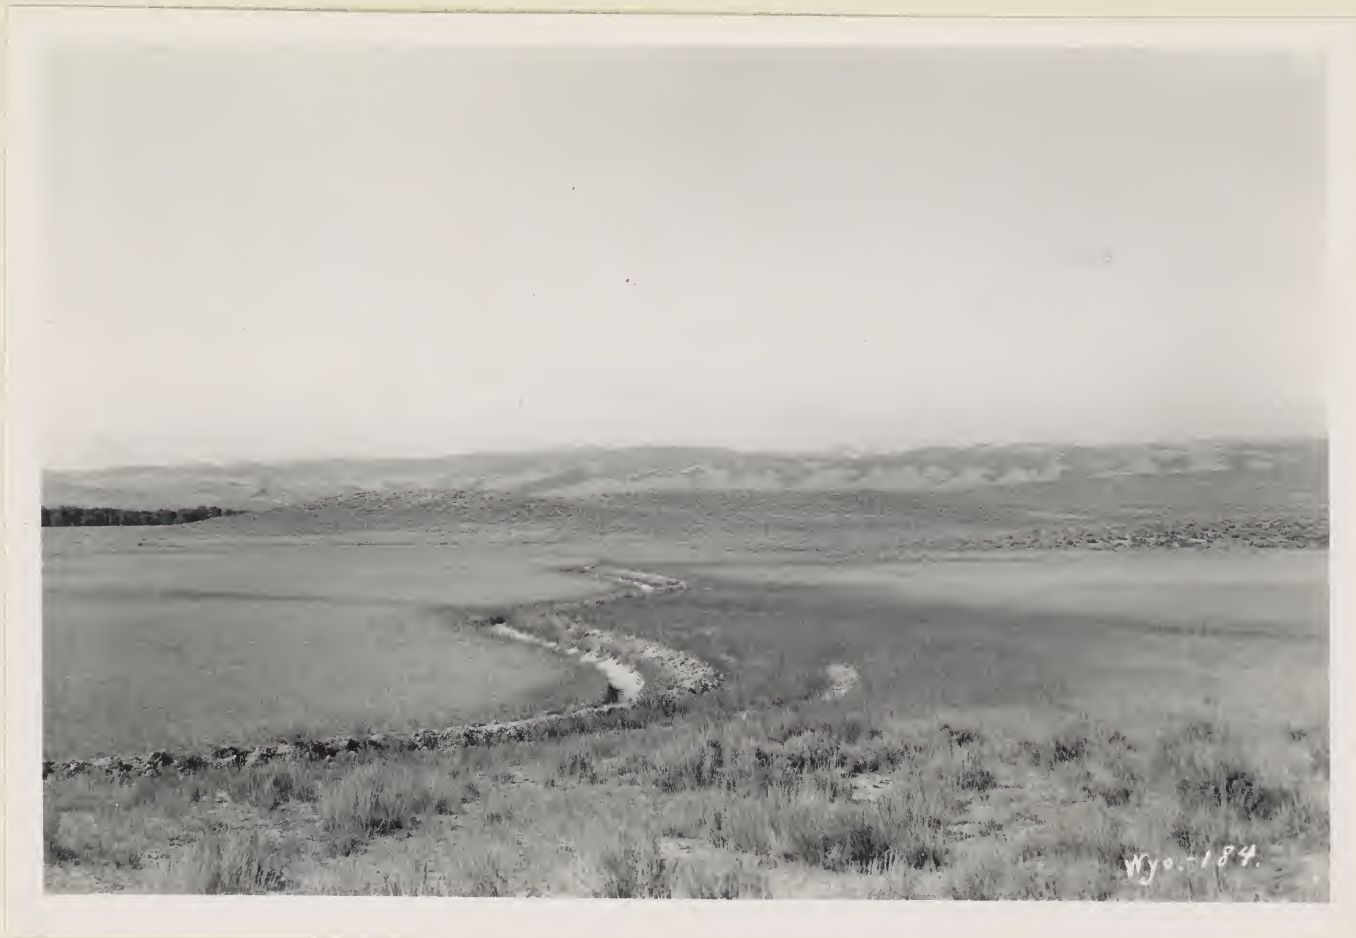
Wyo-184

Effect of water spreading in increasing grass growth in the Big Horn draw on Lander Soil Conservation Service area near Riverton, Wyoming, is shown in this picture taken 2 miles north and west of Ethete, where the drainage empties into the Little Wind River. The more luxuriant, greener grass, chiefly western wheatgrass and grama, out from the spreader ditches where the water extended, is plainly noticeable in the photograph, taken after summer rains.

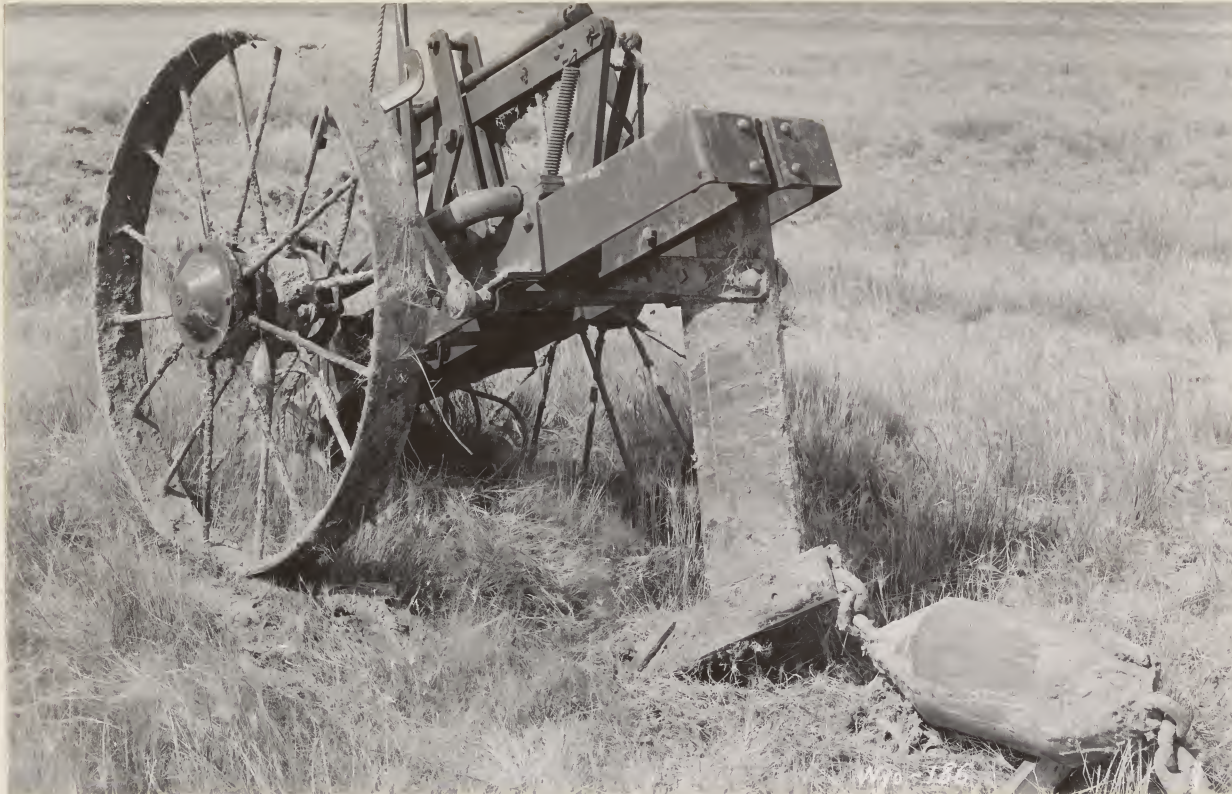
Wyo-186

This killifer chisel, with a "mole" attachment for opening up the soil 3 to 4 feet below the surface was used by the SCS in 1937 in the Riverton irrigated section. The metal, torpedo-shaped device is drawn behind the chisel share and leaves a tunnel. The tunnels made by the "mole", which is approx. 16 inches long and 10 inches in diameter, are run down grade to a waste ditch or other outlet. The implement was tried on fields needing loosening, draining and aerating, in order to make them ready for applying crop rotations worked out in cooperation with the Service. It was intended that the tunnels, which may be farmed over, should remain open several years.

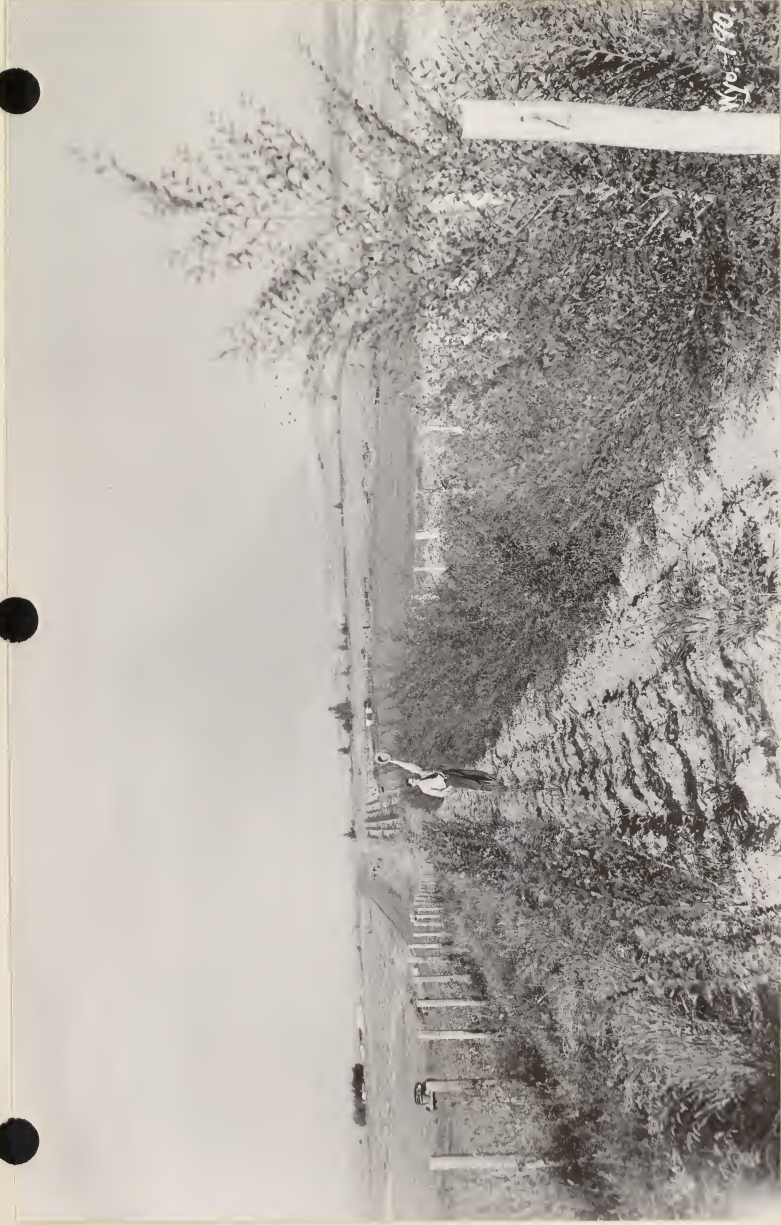
Wyo-190

This two-year field windbreak planted in cooperation with the Soil Conservation Service on the John Doughty place six miles east of Riverton, Wyoming had attained good growth and was in thrifty condition when this picture was made late in August, 1937. It consisted of caragana, Russian olive and Chinese elm.

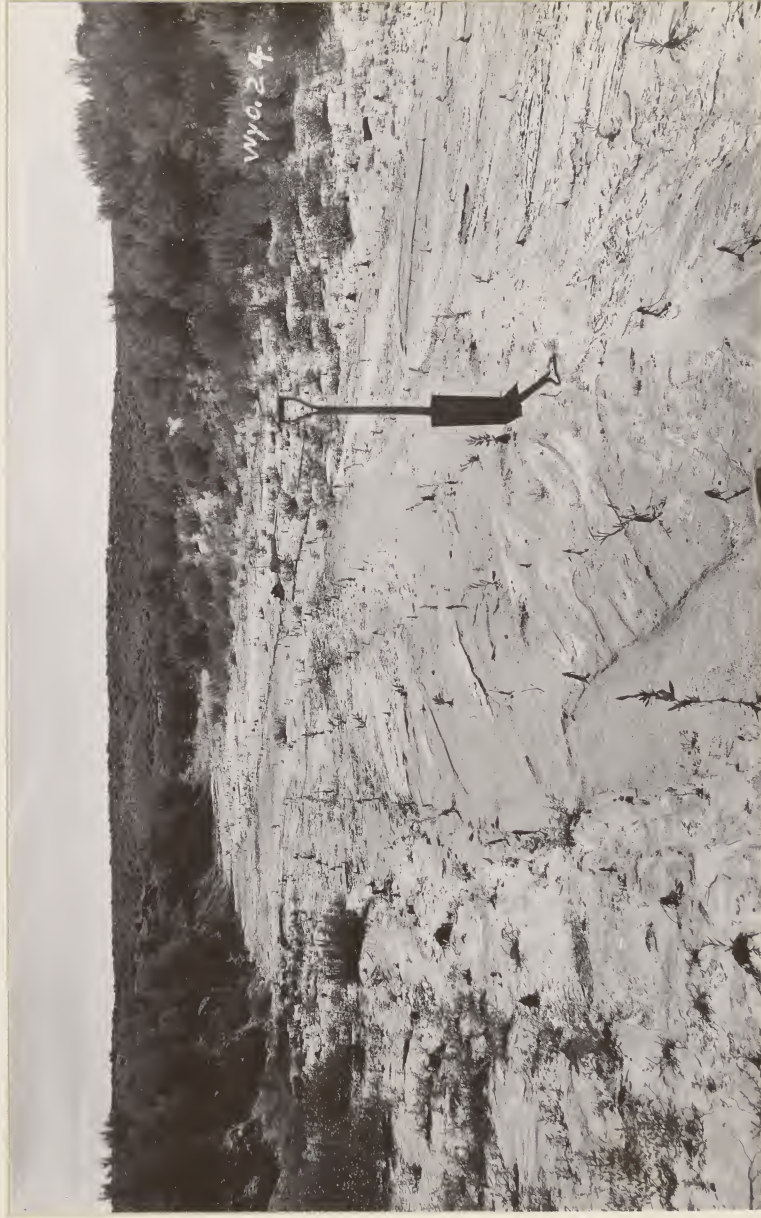
Wyo-24

Tree plantings in sand arroyo or gully. Willow trees. In time these trees will hold the silt until the arroyo fills.

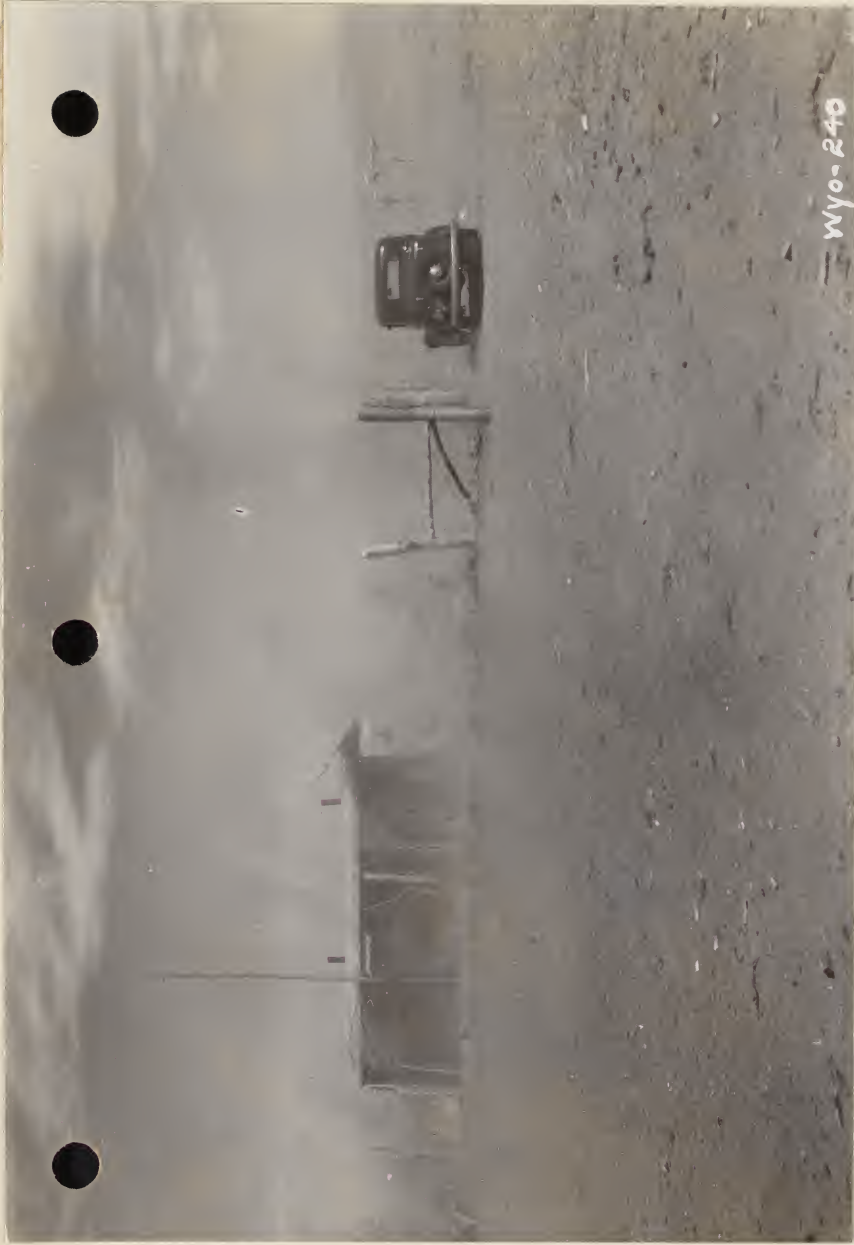
Wyo-240

This dust blowing is seen here around the farmstead on the R. E. Novotny place 17 miles northwest of Riverton, Wyoming. Note the limited visibility resulting from the soil movement. Novotny's plan was to put his entire farm into alfalfa.

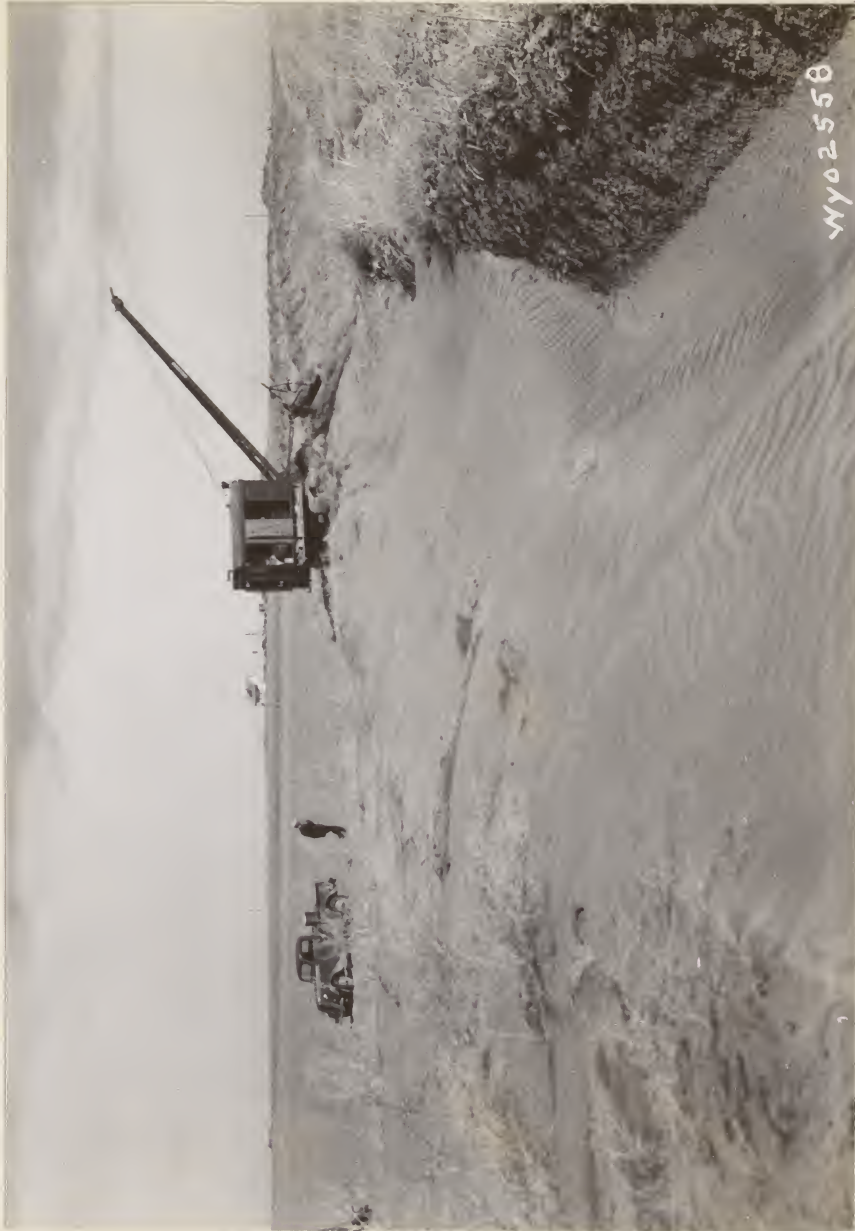
Wyo-2558

This dragline was at work on a Goshen Irrigation District lateral, removing "blow" soil accumulated during the winter of 1936-37 from dry land seeded to winter wheat.
